SUNFLOWER TURBOALTERNATOR CSU I-3A

4329-HOUR-TEST SUMMARY REPORT

Prepared under Contract No. NAS 5-462 by
THOMPSON RAMO WOOLDRIDGE, INC.
Cleveland, Ohio
for .

NATIONAL AERONAUTICS AND SPACE ADMINISTRATION • WASHINGTON, D. C. • APRIL 1965

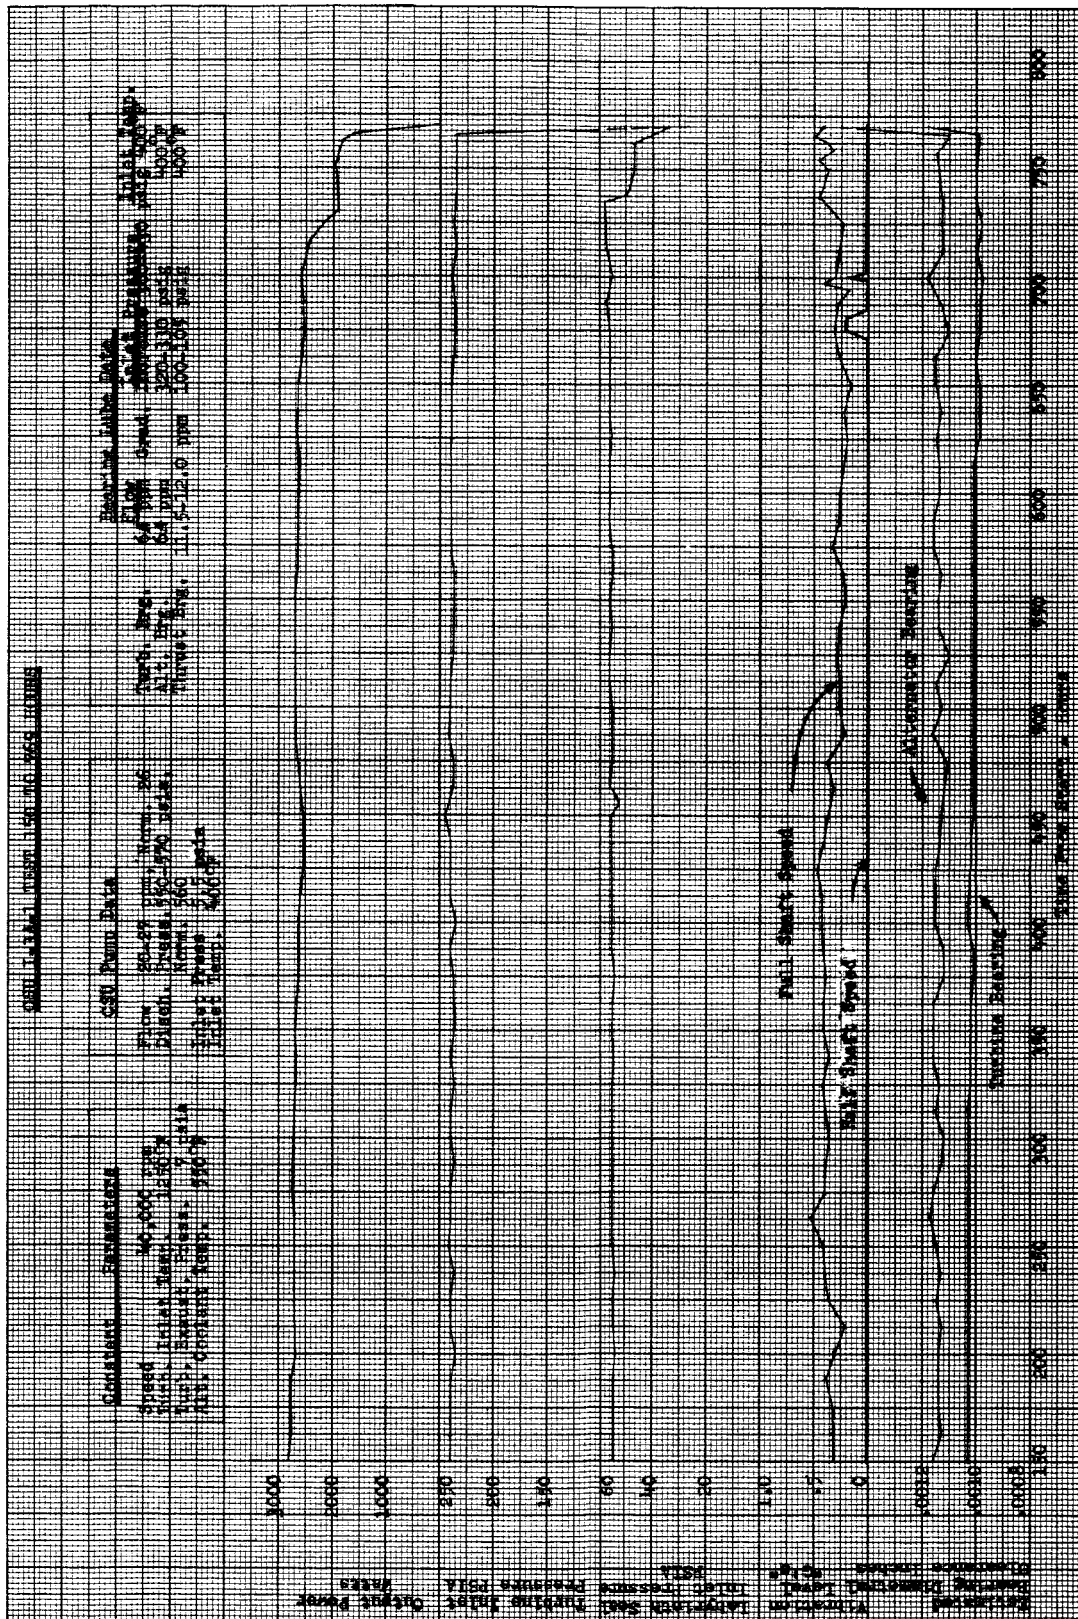
FIGURE 5

Figure 5 shows the plots of significant parameters versus time during the endurance run. A gradual decline in output power can be noted. It was suspected that the heat loss from the turbine inlet housing was sufficient to result in wet vapor entering the first stage nozzle. This condition can result in corrosion products collecting in, and partially blocking the nozzle passages. If true, the reduced nozzle throat area would lower the weight flow through the turbine and thus reduce its output. The turbine inlet housing heater was activated to alleviate this problem.

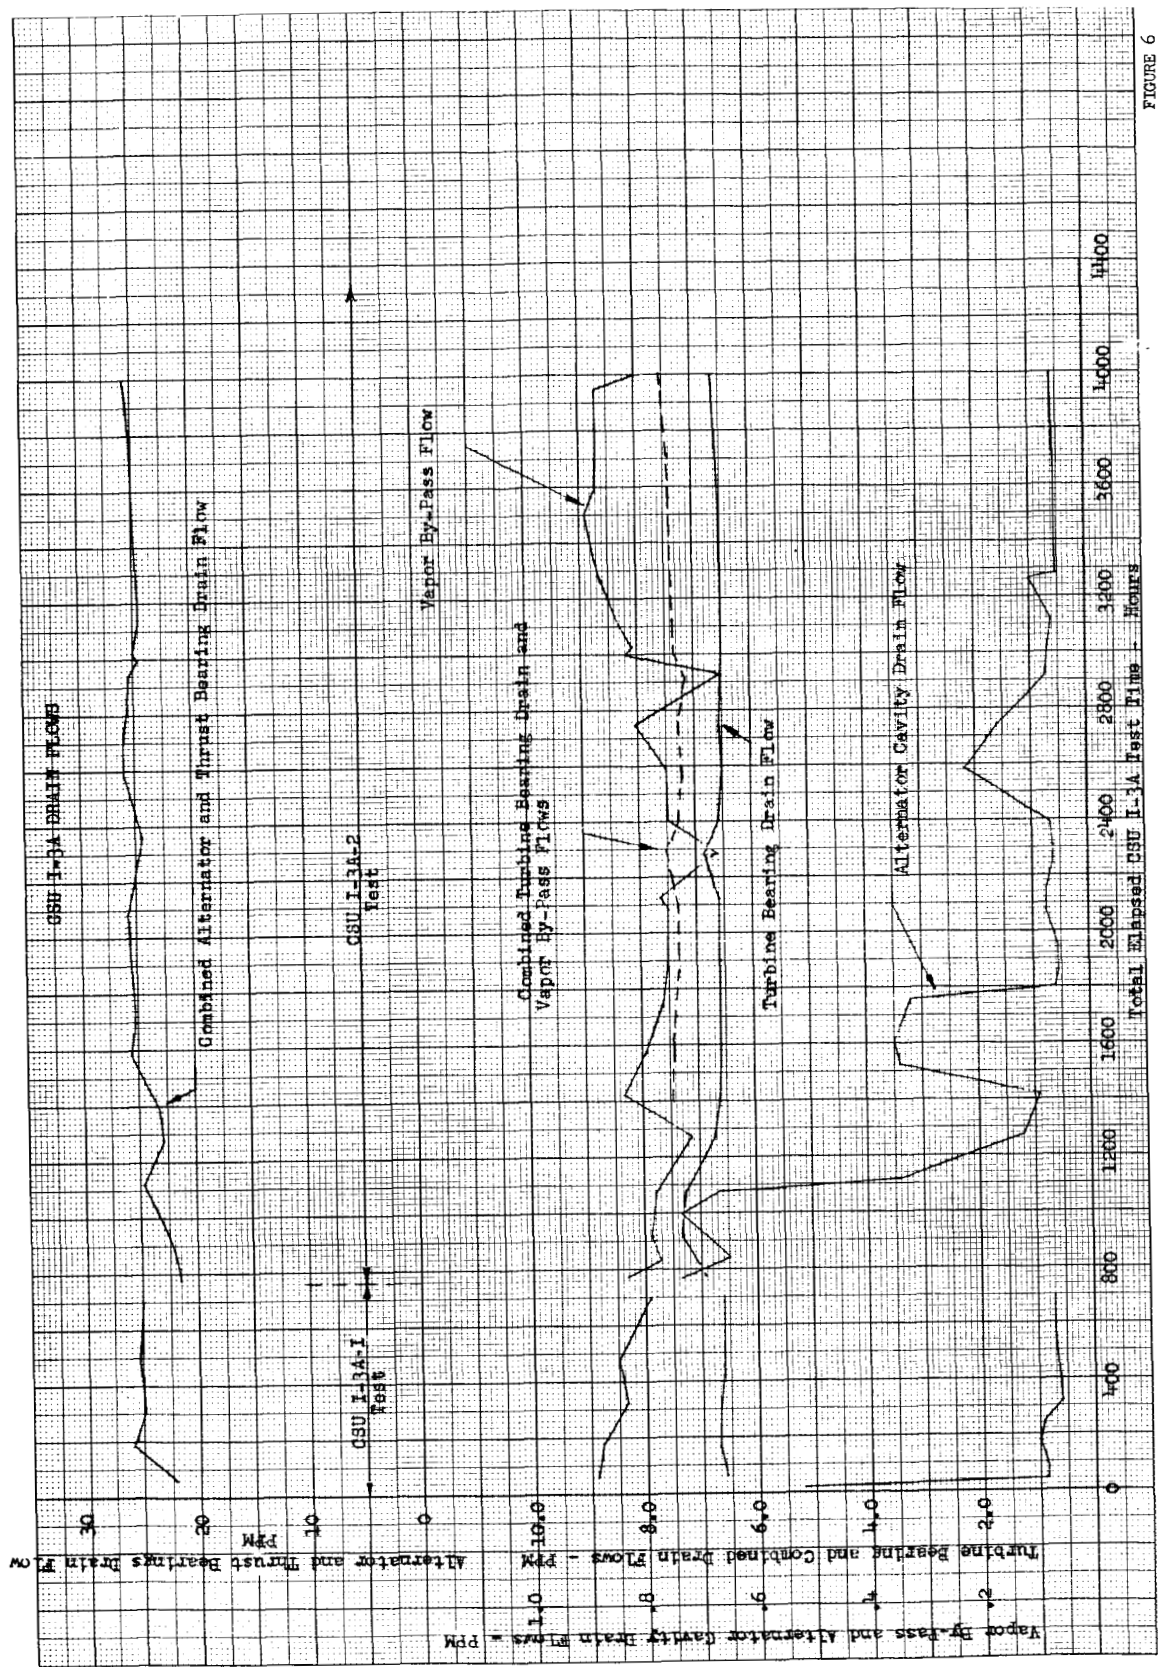
FIGURE 6

Throughout the testing of CSU I-3A, periodic measurements of all drain flows were made and the results are presented graphically in Figure 6. During the first 150 hours the turbine bearing drain flow nominally was 6.6 ppm which agreed very well with the indicated 6.4 ppm lube flow. This slight discrepancy remained constant for all CSU I-3A testing. The alternator and thrust bearing drain flow was somewhat erratic for the first 200 hours but settled out at 25 ppm which was 7 ppm more than the total alternator and thrust bearing lube flow. This discrepancy remained constant throughout the CSU I-3A test indicating that this drain flow was a valid check on the bearing lube flow accuracy. Backface leakage from the CSU pump accounted for the additional 7 ppm flow. Vapor by-pass flow was approximately 0.85 ppm. The alternator cavity drain flow, however, was quite erratic and as previously mentioned had an appreciable effect on CSU performance. Initial measurements of this flow indicated

a flow of .5 ppm but after a short period of time settled out slightly less than .1 ppm. In the sections describing later portions of the test the alternator cavity drain flow will be discussed in more detail.

As shown in Figure 6 the alternator cavity drain flow remained at a high level during the first 300 hours despite continuous efforts aimed at reducing the flow by varying pump flow and turbine exhaust pressure. The power output of the CSU was correspondingly low.

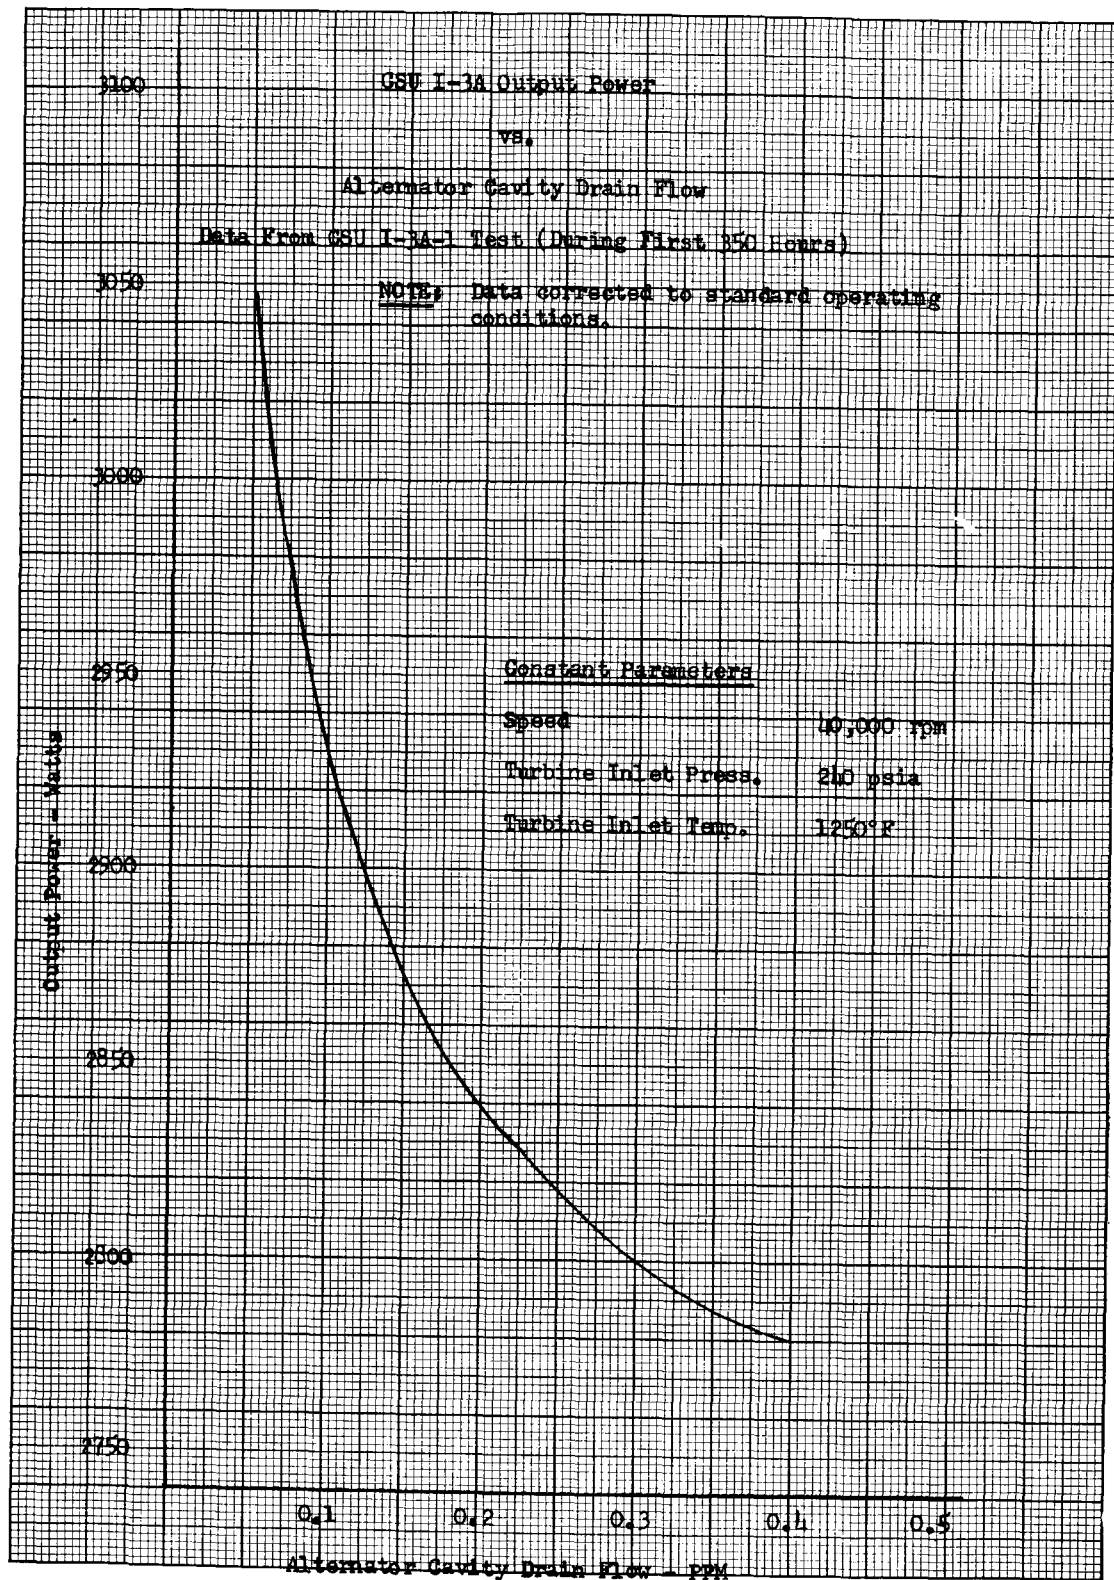
At an elapsed time of 725 hours, however, there was a step change

To more accurately evaluate the performance of the unit at a given instant, measurements of the variation in output power as a function of turbine inlet and exhaust pressures were made. Using this information the power output could be corrected to standard operating conditions for comparison with previous data. Applying these corrections and taking into account the effect of alternator cavity drain flow showed that after 550 hours the decay in power output was 300 watts. However, it had remained constant for the preceeding 300 hours which coincided with the reactivation of the turbine housing heater.

in power of about 600 watts. At the same time the turbine interstage pressures and boiler power both dropped off which indicated reduced vapor flow through the turbine. Approximately 40 hours later there were additional step reductions in power and at 769 hours the power had dropped to 1600 watts. All indications were that the first stage nozzle was plugging. To avoid operation at low power and to preclude the possibility of shaft seizure the test was shut down. The unit was removed from the test rig and partially disassembled.

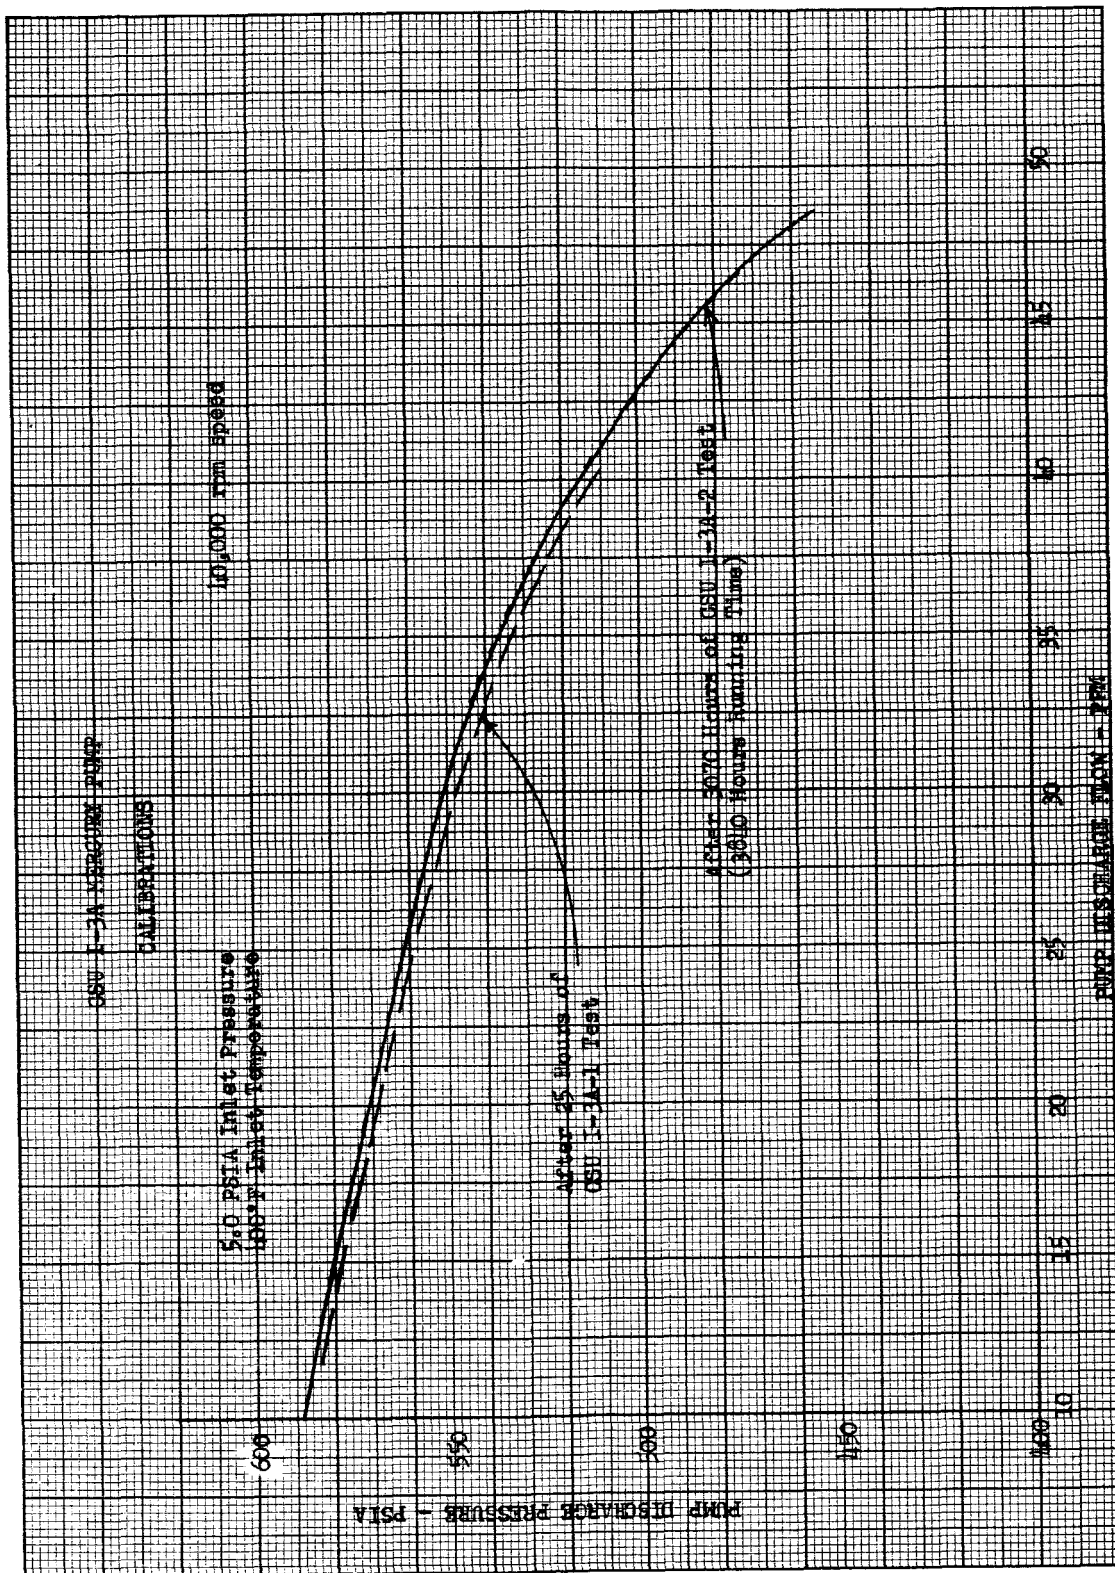
FIGURE 13

the initial performance of the CSU I-3A-1 test. In fact it was slightly improved as shown in Figure 13. The curves compare calibrations before and after a span of 3815 hours operating time. This performance is well above design and is especially significant since severe erosion of the pump impeller was noted during disassembly. The condition of the impeller is discussed in section 7.1.

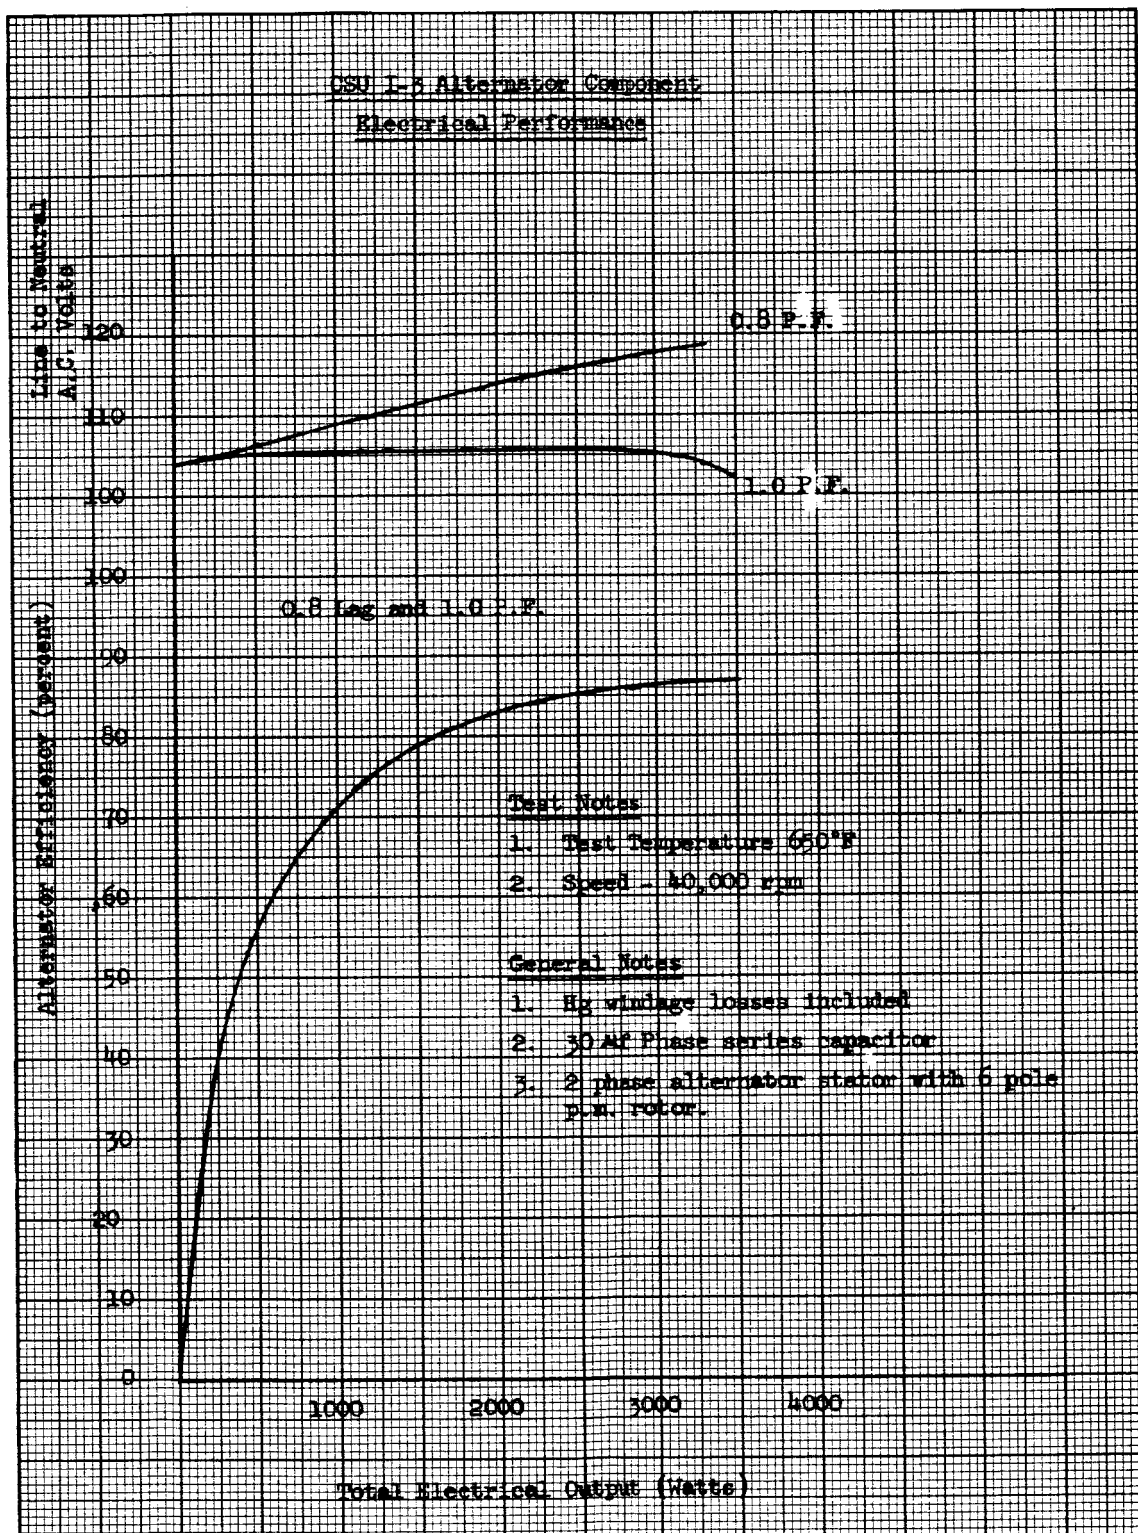
FIGURE 19

The stator portion of the alternator was used in the CSU I-3 2350 hours endurance run and was reused in CSU I-3A without rework. It thus accumulated a total of 6676 hours of operation with all but the last 300 at, or very near, design level. As explained earlier in this report the permanent magnet rotor was inadvertently partially demagnetized to a level of 70 volts near the end of the CSU I-3A-2 test. With the turbine operating at design conditions the output power was reduced about 50 watts which indicates a decrease in efficiency from 86% to 84%.

A slight bore seal leak developed during the CSU I-3 testing so the normal precaution of maintaining a positive internal pressure in the stator was taken during the CSU I-3A test. Up until the final failure, when the glass bore seal melted, there was no positive indication that the leak became more severe.

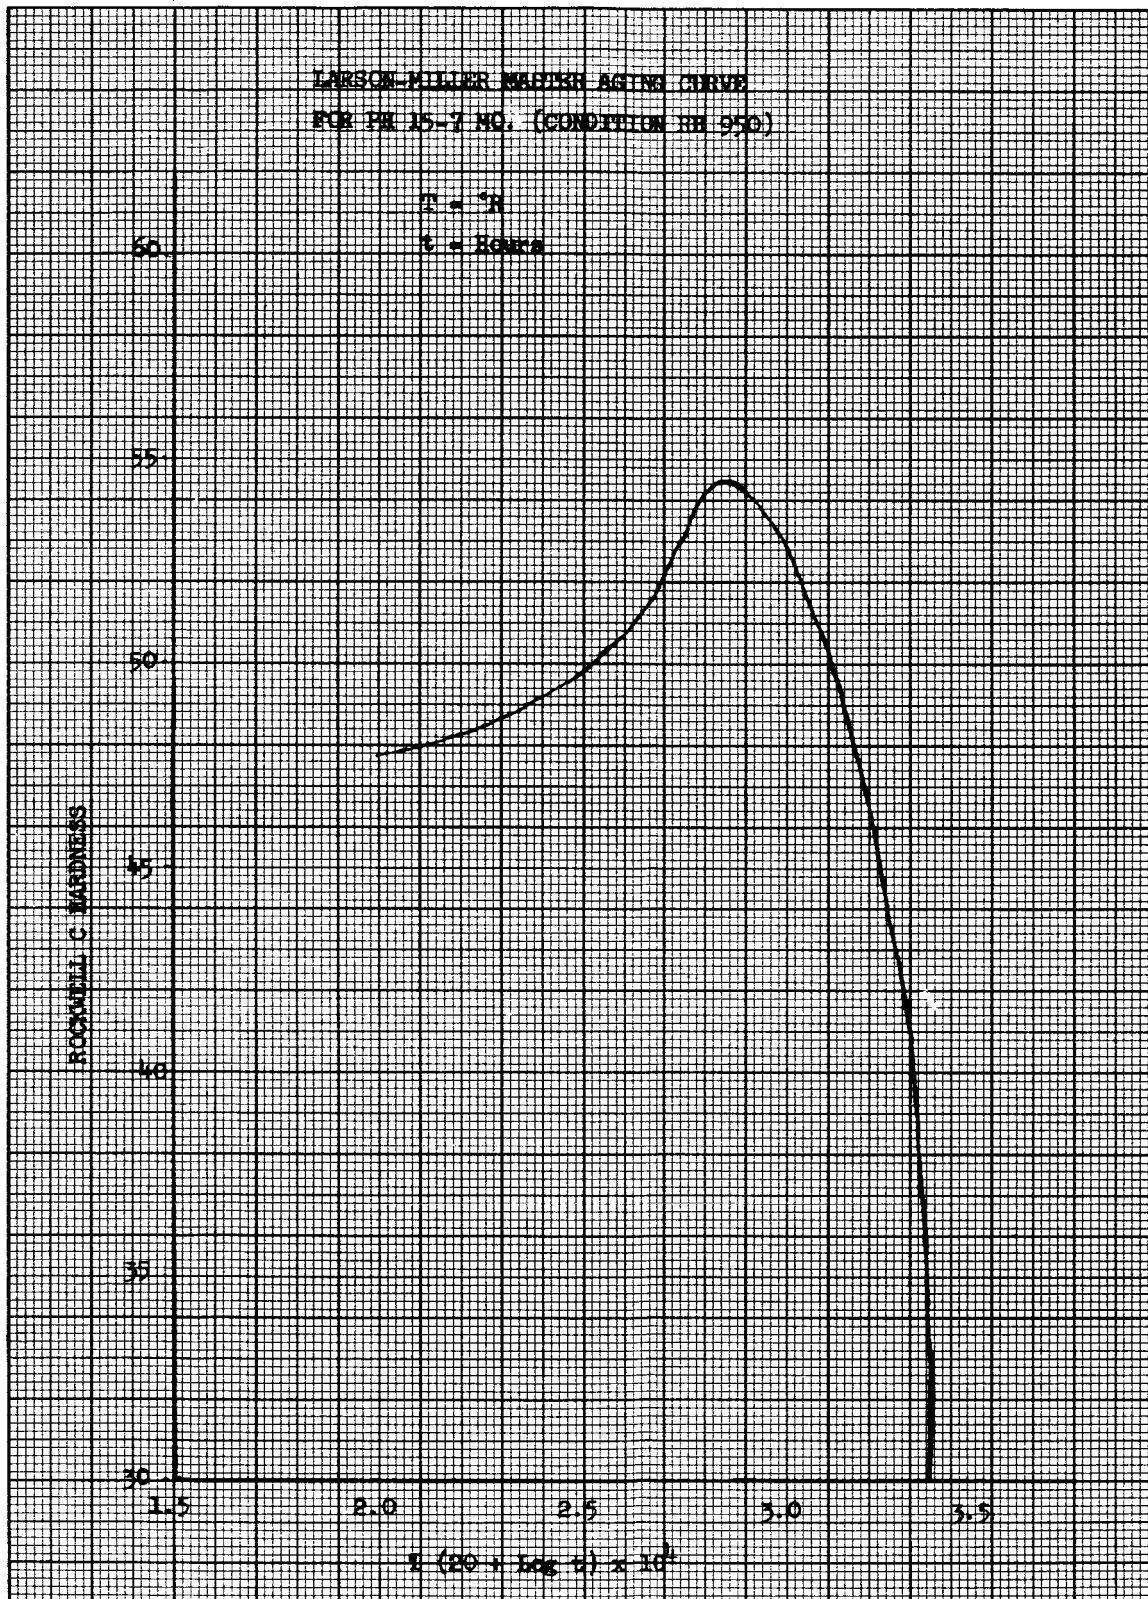
The turbine blades of the third stage wheel had evidence of erosion on the convex side of the leading edge, with little or no erosion on the blade surface areas. Erosion depth was estimated to be 1.6 mils. Some corrosion up to .4 mils was noted on localized working surfaces of the blades. An operating temperature of 700°F was confirmed from the hardness changes incurred during operation. The Larson-Miller master aging curve shown in Figure 34 illustrates how temperature predictions can be made.

The alternator rotor can showed no defects other than several pits and a growth change of .005 inches in the middle of the can which was attributed

to both creep and overspeed. The operating temperature was estimated to be 890°F. Approximately 80% of the growth of the can is attributed to creep during operation due to the martensite tempering and carbide precipitation noted along the delta ferrite stringers.
